SUBJECT: LA-6 Model

DATE: March 1 , 1934

This Bulletin supplies detailed supplementary information to that issued in Machine Service Bulletins No. 161, Supplements A, B, C and D, and 165, 167 and 177.

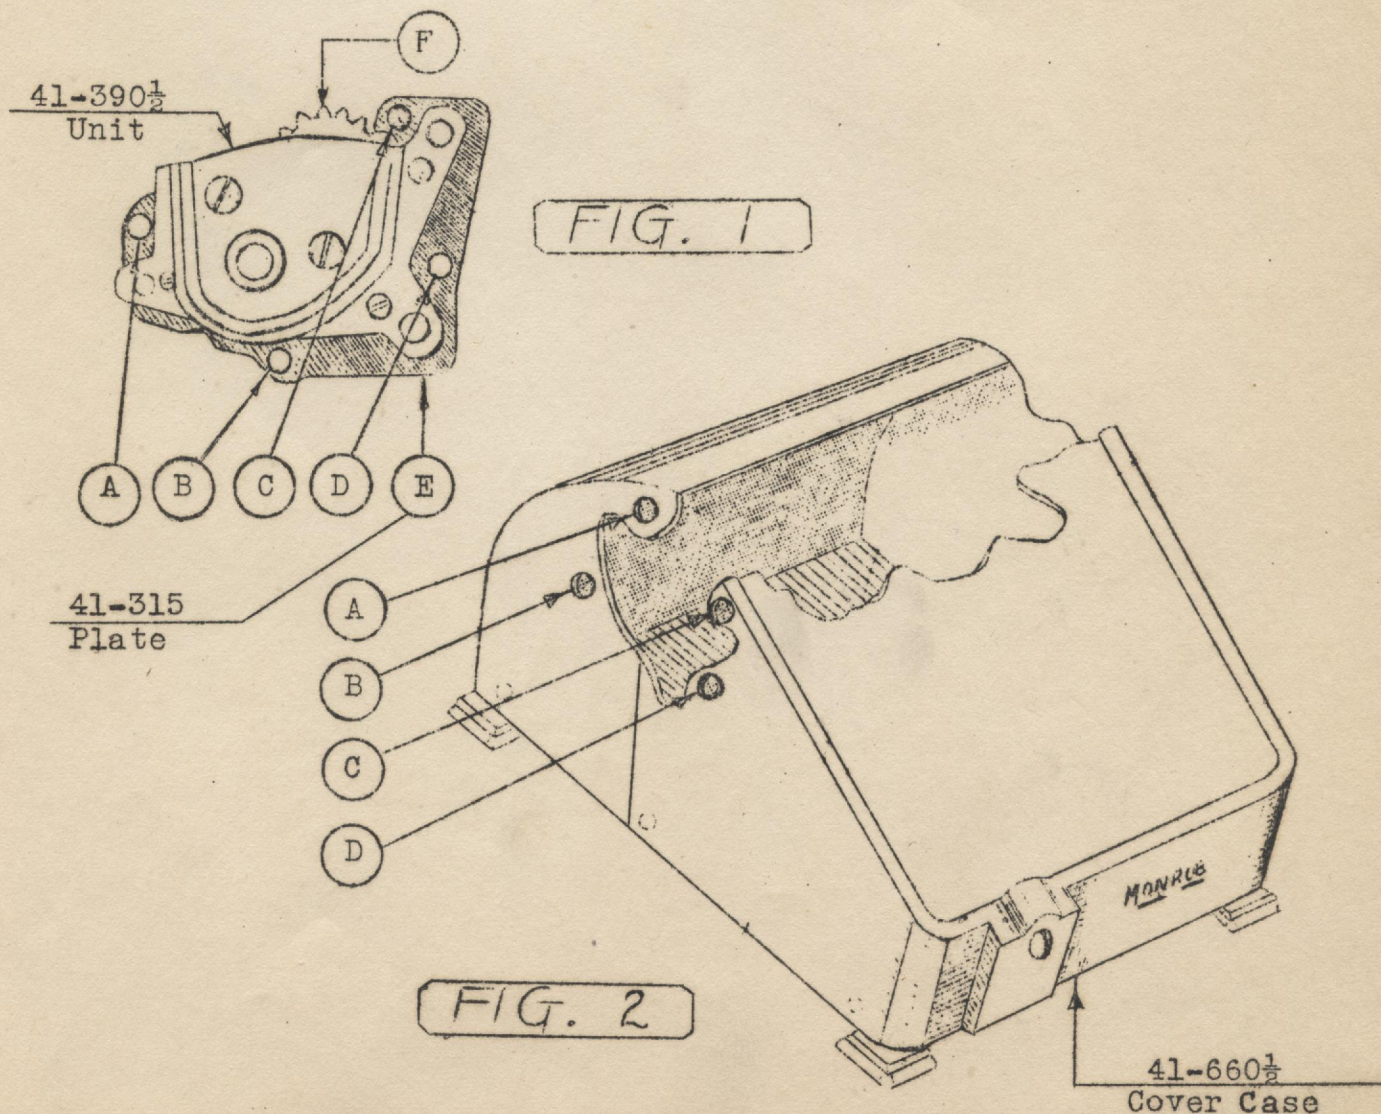
The fastening of the machine cover case, 41-660 $\frac{1}{2}$ , to the through carry unit, 41-390 $\frac{1}{2}$ , with screws 50506 through holes (A), (B), (C) and (D) may disturb the correct alignment of the extreme left hand extra carry gear (F) with the intermediate gears. This is due to the strain set up by the tightening of these screws. Machines in perfect operating condition often function improperly on account of this. Therefore, the use of shim washers between the end plate (E) and the cover case was resorted to. However, a change has been made in the cover case which eliminates holes (A), (B), (C) and (D) and omits the use of screws 50506.

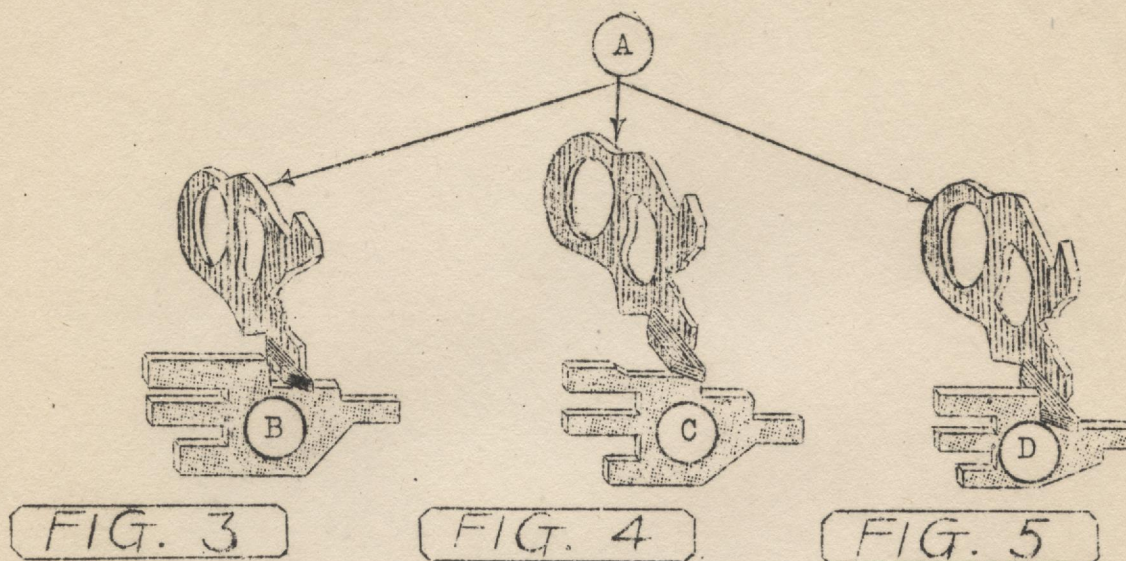
An improvement has been made in the carrying dogs by adding a small amount of stock on the top of the dogs at the points where they contact the feet of the wedges. See (B) and (D), Figure 6. In LA-6 models, due to the use of round tooth gears in the extra carry unit, it is necessary to set a slightly higher mesh between the dial gears and intermediate gears than in other L models. This higher mesh causes the wedges (A) to be depressed slightly later by the carrying pins than with the deep mesh, and we have found that this delay, even though it is slight, causes the wedges, when they are depressed, to strike the top of the dogs rather than to drop in front of them. In order to overcome this condition, we have added a small amount of metal to the top of the dogs so that the delay in depressing the wedge is compensated.

Figure 3 illustrates the correct engagement of wedges (A) with the new style 2416 dogs (B).

Figure 4 shows the incorrect condition caused by the wedges (A) dropping late and riding on top of the 2416 old style dogs (C).

Figure 5 illustrates the correct engagement of the wedges (A) with the new style 2417 dogs (D).

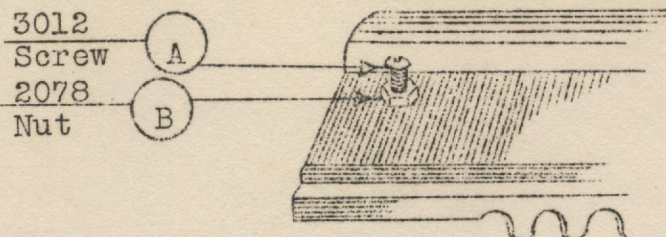
FIG. 7

Set screw (A) has been provided to limit the movement of the trip rod (H) when the constant key is depressed.

If the correct number is not registered when setting the constant into the carriage and the machine is without this feature, install screw (A) and nut (B) by following the instructions listed below. NOTE: After installing screw (A) and nut (B), if the correct number does not register when setting the constant into the carriage, adjust screw (A) up or down until the trouble is corrected.

- 1 - Position the rocker arm assembly (D), as shown. Raise stud (C) with the fingers as far as possible. In doing so, lug (F) contacts the carriage case (E) and leaves a slight mark as indicated by (G).
- 2 - Center punch this mark.
- 3 - Drill a hole through the case with a #50 drill, using the center punch indent as a guide.
- 4 - From the outside of the case enlarge the hole with a #49 drill and tap it with a 2-64 tap.
- 5 - Install nut (B) on screw (A) and insert (A) in the case to suit and tighten (B) securely.

NOTE: To allow for free movement of rocker arm (D) after installing screw (A), it may be necessary to grind (D) at (F).

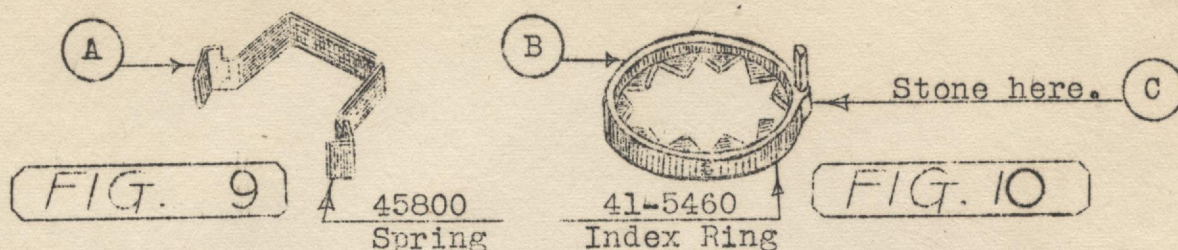
If wrong figures are registered when the constant is being set into the carriage, it may be due to springs (A) being too weak, strong or broken. Faulty dial plunger action will also cause this trouble.

The left hand ends of the dial collars (D) have been reduced slightly in diameter so that they may be assembled more easily. If collars (D) have a flat on the flange which form a bearing for the index ring (B) the corners (E) on the left side should be broken with a stone.

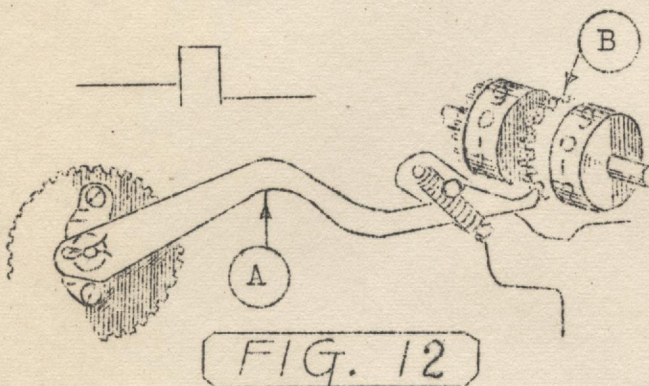
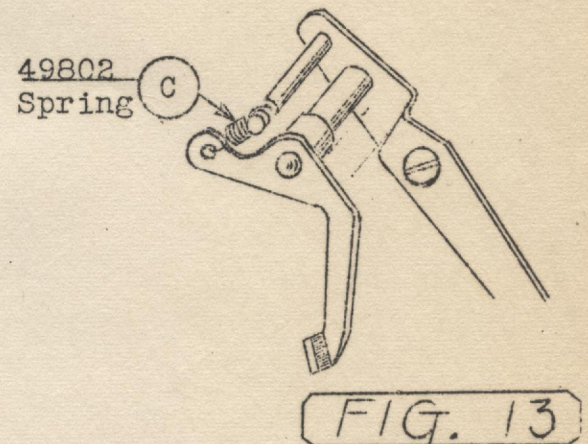
If a "1" is left in the multiplication counting dial, arm (A) is not in correct adjustment with (B), or spring (C), 49802, is too strong.

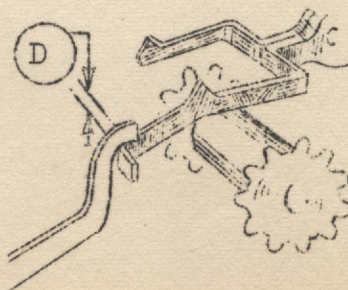
If, after the multiplication counting dial has been returned to zero the machine continues to run in the forward direction, or if the machine continues to run in a forward direction when the carriage shifts to either of the first two column, (D), Plate 8, is not adjusted close enough to the carry pin. NOTE: Whenever changing this adjustment, it is necessary to change the adjustment of (H) by bending (G). See Plate 8.

Excess clearance at (D) may also cause this trouble. See Figure 14.

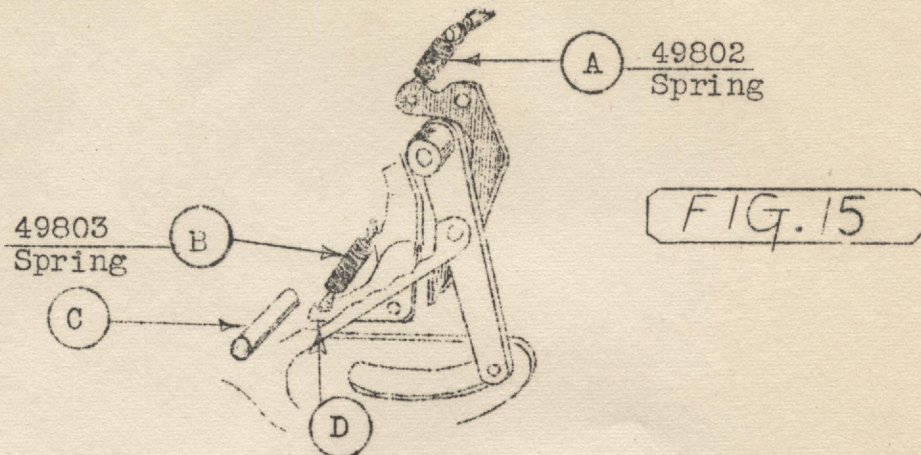
If the mechanism trips and shifts before the multiplication counting dial comes to zero, ascertain if spring (B) is too strong. If so, it should be weakened. If this does not remedy the trouble, spring (A) should be strengthened. However, if (A) is too strong, the figure "1" will be left in the same dial after multiplication. If adjusting the spring tension of these two springs does not remedy the trouble, the clearance (J), Plate 8, should be increased.

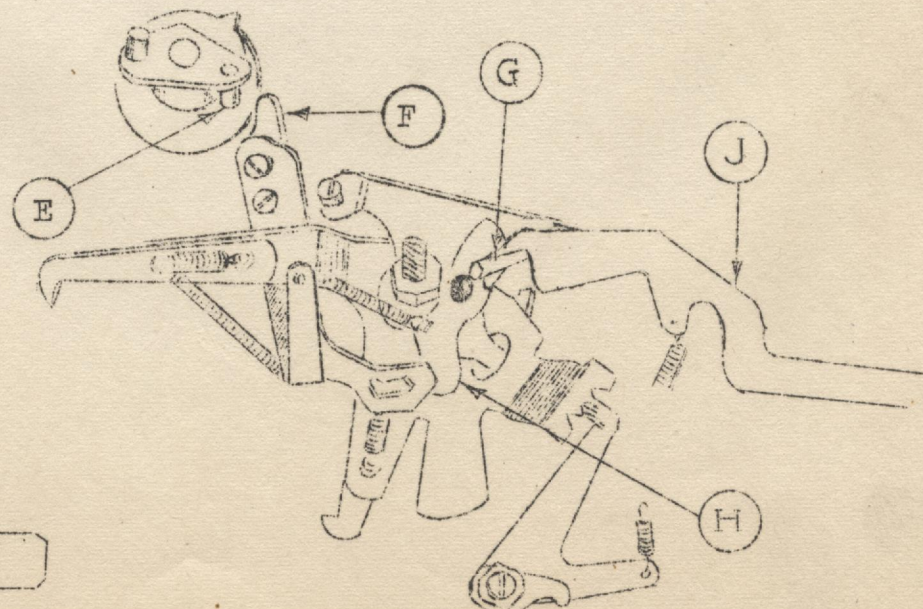
If a machine makes one or more reverse cycles after shifting in multiplication, latch (D) is adjusted too far from pin (C), or there is too much clearance at (J), Plate 8.

If the machine continues to run forward after the carriage has shifted to the first column in multiplication, pin (G) on end of the division lever is not properly adjusted by the division lever click (J) in relation to latch (H), to reset the clutch yoke trip arm to neutral.

If the machine should shift and stop in either multiplication or division, (F) is not properly adjusted to (E).

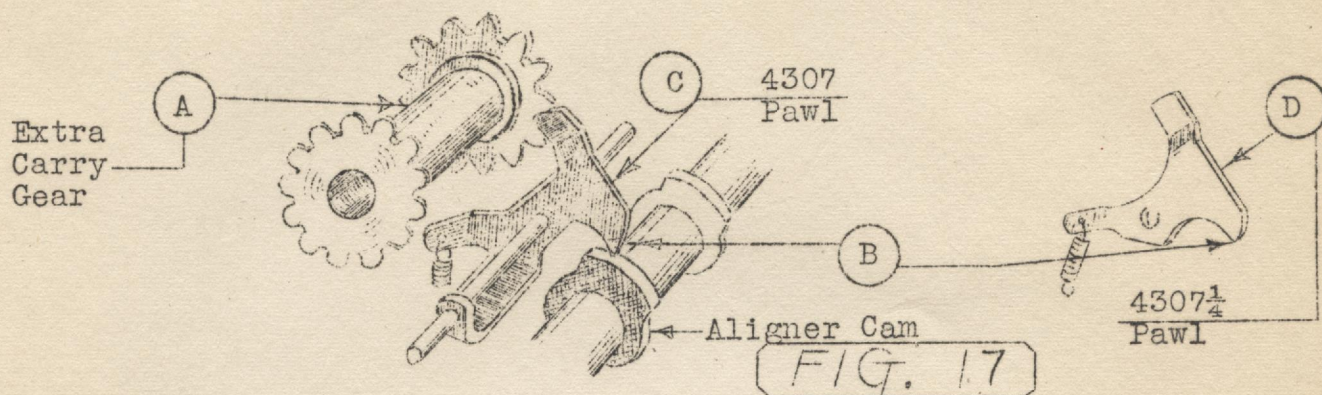
Nines Do Not Clear Out in Lower Dials, Caused By Through Carry Unit Locking Up:-

When the aligner cams are in position to lock the pawls, the extra carry gears should have a very slight amount of play. To overcome a condition whereby too much clearance exists at this point, peen the pawl (C) or (D) at (B) to suit. In some cases the installing of new pawls may remedy this condition.

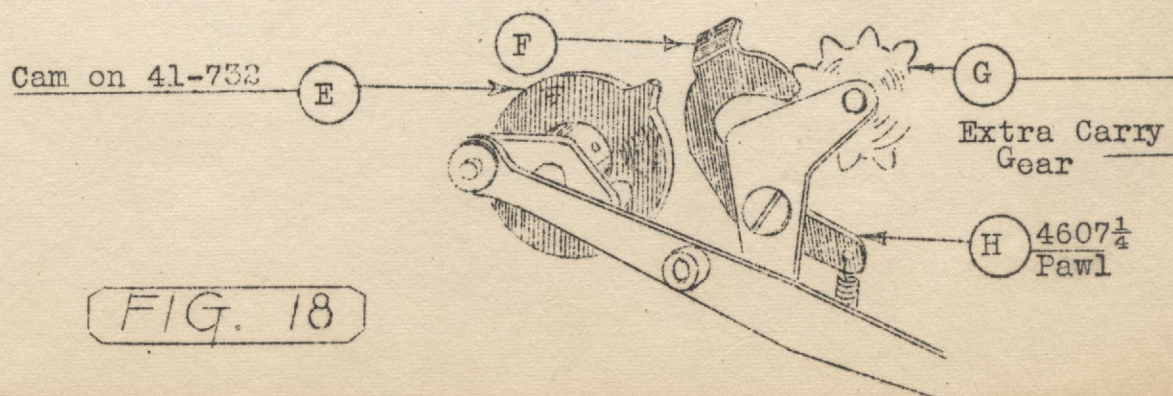
Often, binds in the extra carry gears (A) are the cause of the unit locking up. Therefore, it is advisable to determine the freedom of these gears by disengaging pawls (C) and (D) from them.

A condition occurs occasionally wherein one of the pawls (C) is locked against the extra carry gear before the cam (E) on the 41-732 of the carry shaft has positioned pawl (H) into full engagement with the First extra carry gear (G). To remedy such a condition bend lug (F) slightly forward or rearward to hasten its engagement with (E) in accordance with the direction in which the machine was operating when this trouble occurred.
